FLOODS IN THE AÑASCO AREA, PUERTO RICO

This hydrologic atlas provides factual and interpretive hydrologic information. The information can be used by the planner, designer, or any interested person, to reach more rational decisions related to land use in the flood plain of the lower reaches of Río Grande de Anasco. Among the data presented are tabulations of flood stages, stream-flood profiles, and area of inundation for the flood of September 13, 1928, on Río Grande de Anasco, and the area inundated in the vicinity of Anasco by floodwaters of Río Dagüey on August 12, 1956. Stage-frequency curves are presented from which the magnitude of future floods of selected recurrence interval can be estimated. Areas of inundation and flood profiles are specifically for valley conditions that existed at the time of the floods. Some of the information is based on that obtained from interviews with residents in the study area. All elevations are in meters above mean sea level datum.

By
Fred K. Fields
1971

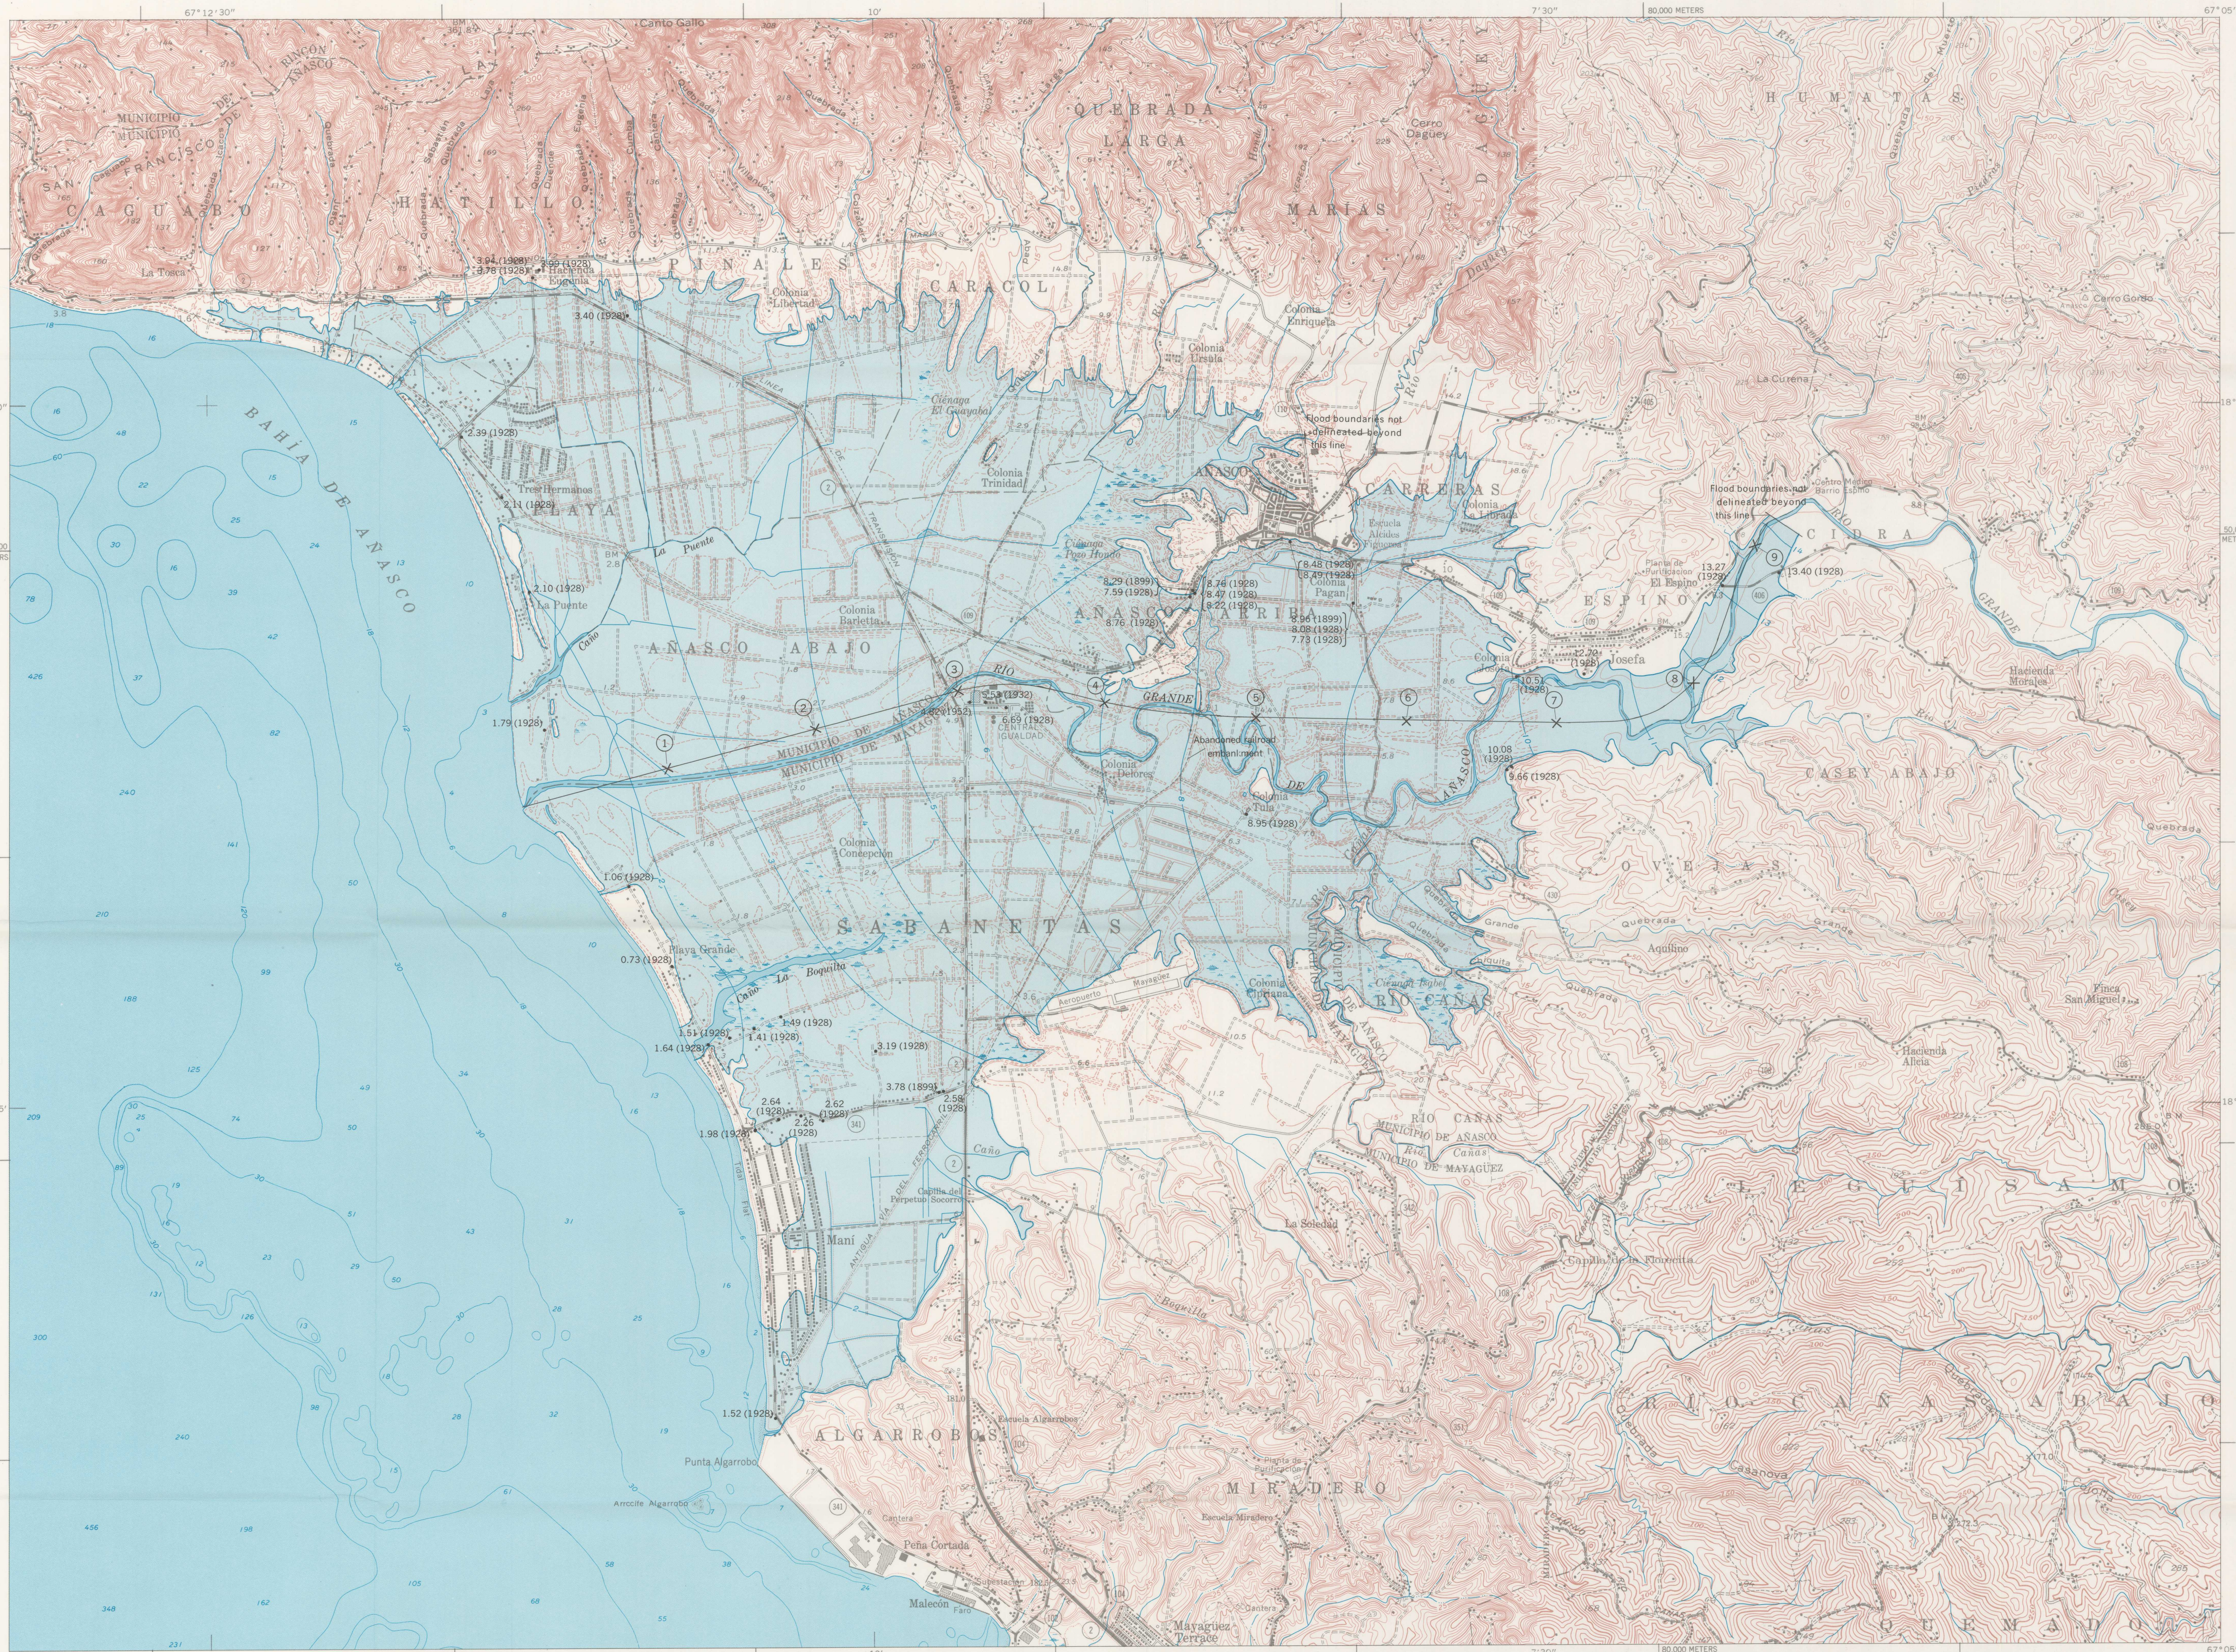
- Flood of September 13, 1928
- Boundary of 1928 flood
- Kilometers upstream from mouth measured along profile base line
- Approximate water-surface contour for 1928 flood. Contour interval, 1 meter (above 2-meter line)
- Floodmark elevation in meters above mean sea level and year of flood

High-water mark information.—The inundated area has been defined on the basis of flood-stage information furnished by local residents. Field surveys were conducted to determine the elevation of flood stages provided by personal accounts. The delineated area is determined from water-surface profiles which represent an average of the individual high-water elevations. Floodmark elevations and locations are shown on the topographic maps. Flood stages are well defined in the vicinity of El Espino, Anasco, Central Igualdad, and the mouth of Río Grande de Anasco; they are poorly defined elsewhere.

The flood boundaries delineated on the topographic maps provide a record of historic facts that reflect channel and flood-plain conditions existing when the 1928 flood occurred. The effect of more recent or future changes in the channel and flood plain, the possible change in runoff characteristics resulting from increased urbanization, and the effect of the four dams in the upper part of the drainage basin are unknown. The Highway PR-2 embankment has been raised and the highway has been relocated east of the indicated position on the north side of the flood plain. The inundation pattern of floods may be affected by Highway PR-2, the possible relocation and improvement of the stream channel, the removal of the railroad embankment, and other cultural changes. The dams may reduce the frequency of flooding, but will not eliminate floods.

Depth of flooding.—Depth of flooding during the 1928 flood can be estimated by subtracting the ground elevation from the water-surface elevation, each shown by contours on the map. Intermediate estimates of depth can be determined by interpolation. The flood will have a 5-percent chance of occurring in any year, and a 50-year flood will have a 2-percent chance.

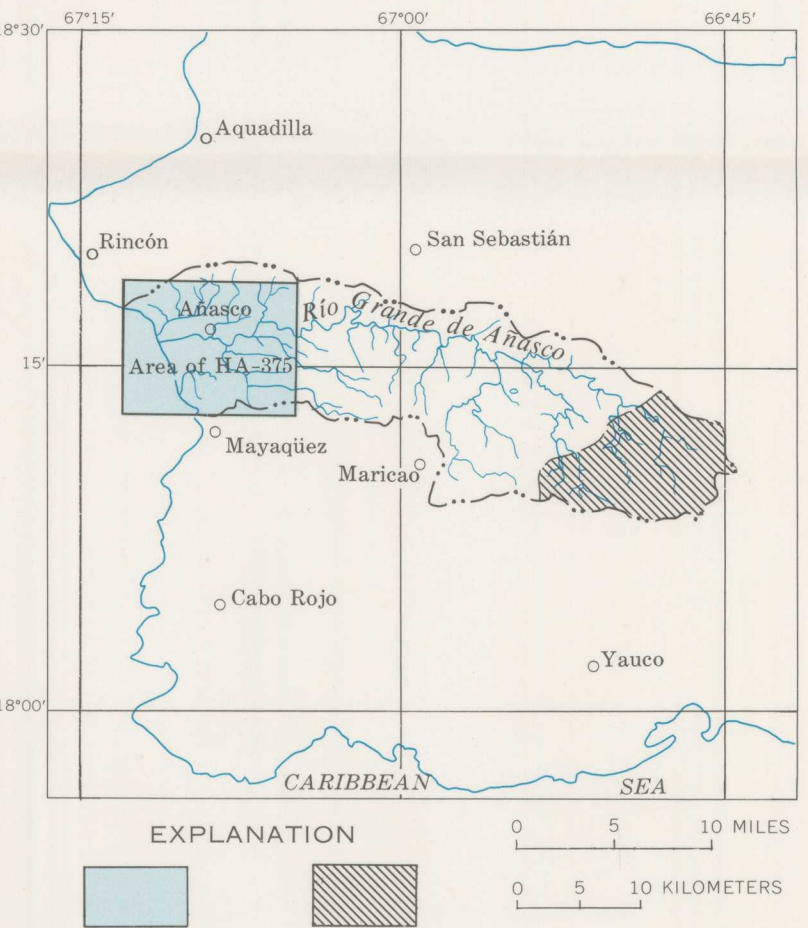
FIGURE 1.—Río Grande de Anasco drainage basin.

Drainage basin.—The Río Grande de Anasco basin lies in the central part of western Puerto Rico, as shown in figure 1. The stream flows west from the rugged Cordillera Central and empties into Bahía de Anasco, on Pasaje de Mona. The drainage area of the basin is 201 square miles, which includes 39 square miles above Lagos Yahuecas, Guayo, Prieto, and Torro. Flow from the interconnected 4-reservoir system is diverted from the Río Grande de Anasco basin and then to Valle de Lajas for irrigation. A schematic diagram of the system is shown in figure 2. The four reservoirs in the Río Grande de Anasco basin, which have a combined storage capacity of 20,000 acre-feet, were constructed during the period 1955-56.
